3-YEAR ASBESTOS RE-INSPECTION REPORT

ROBERT MORRIS ELEMENTARY SCHOOL SCRANTON, PA

**SCRANTON SCHOOL DISTRICT
425 North Washington Avenue
Scranton, Pa. 18505**

PROJECT: #SSD.19_751

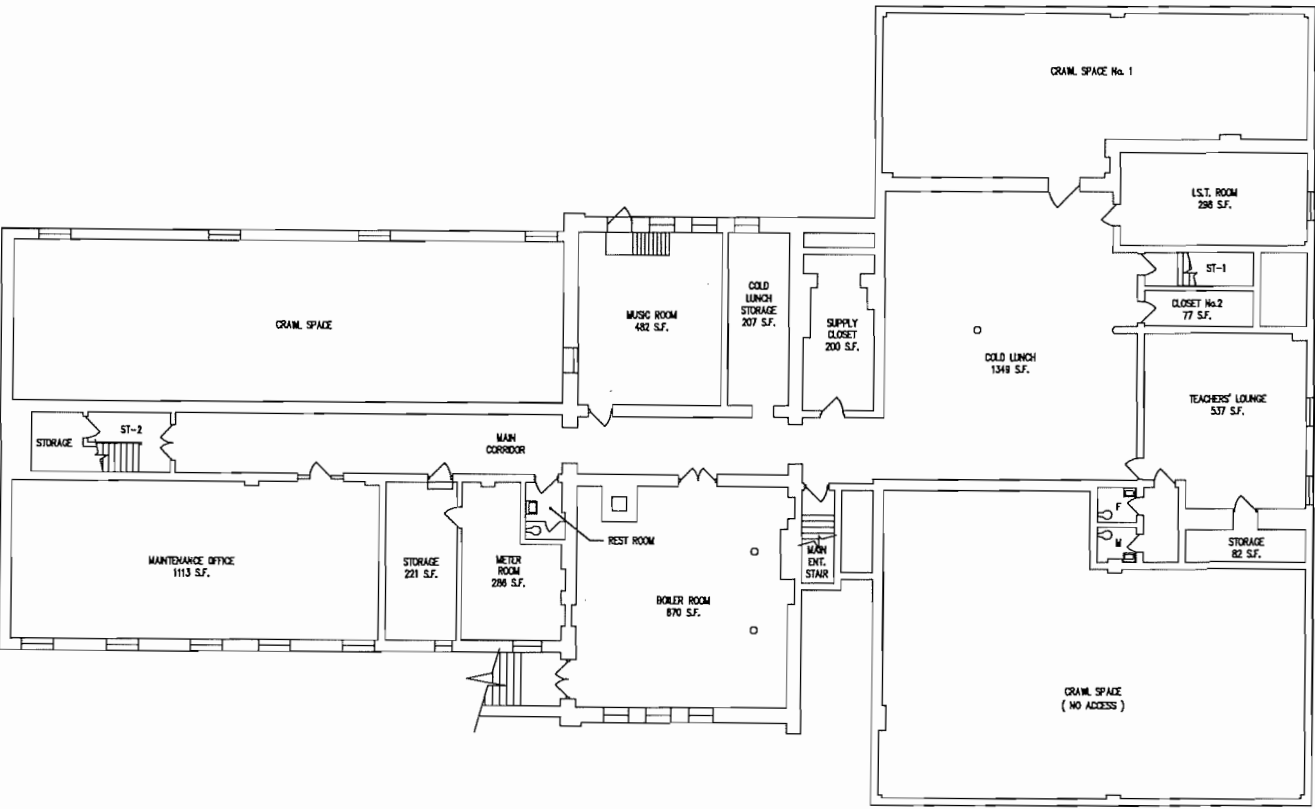
BASEMENT PLAN

NO SURFACING ACBM WAS FOUND ON THIS LEVEL

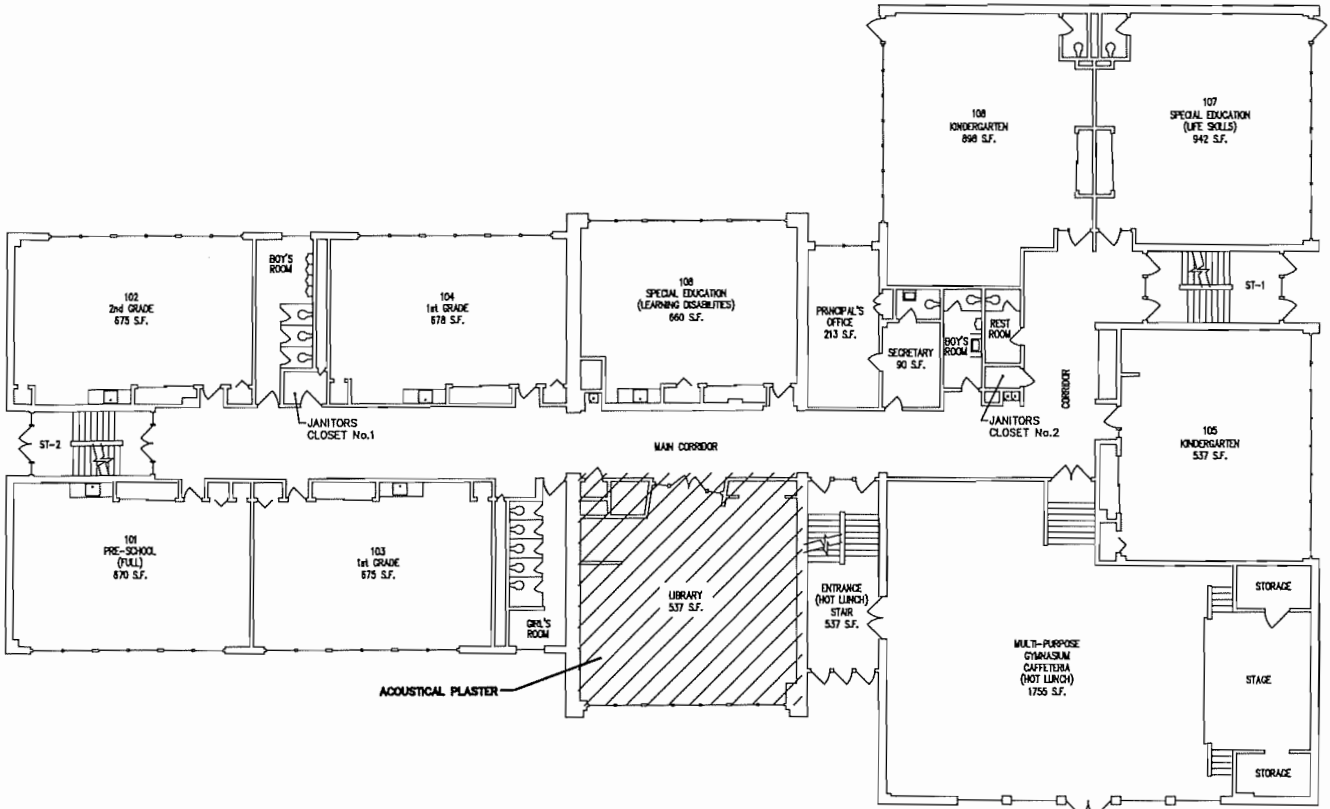
1ST FLOOR PLAN

ACOUSTICAL PLASTER

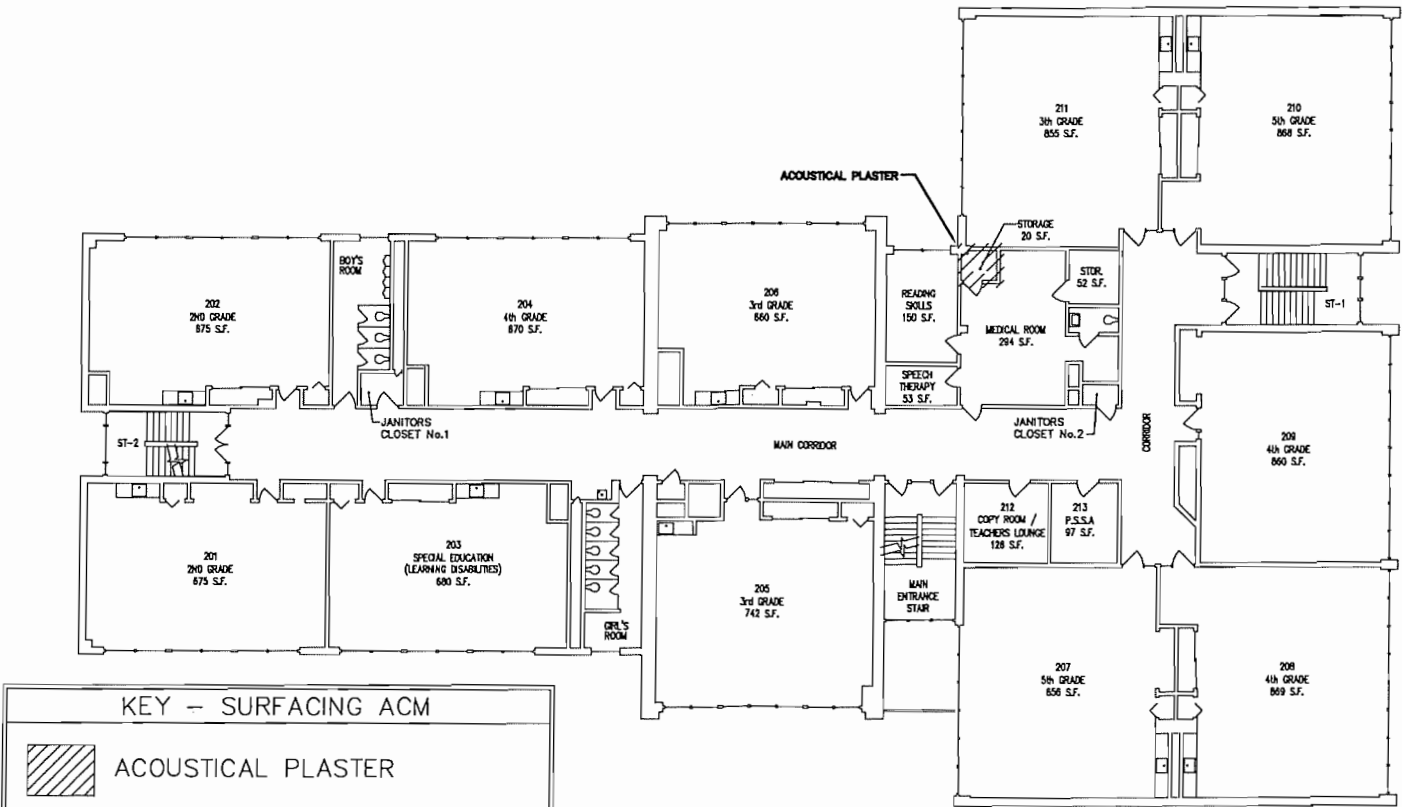
ACOUSTICAL PLASTER
